TEST REPORT

CEPRI-EET02-2023-0058 (E)

Object: Metal Oxide Varistor

Type: $\Phi 60\text{mm} \times 24\text{mm}$

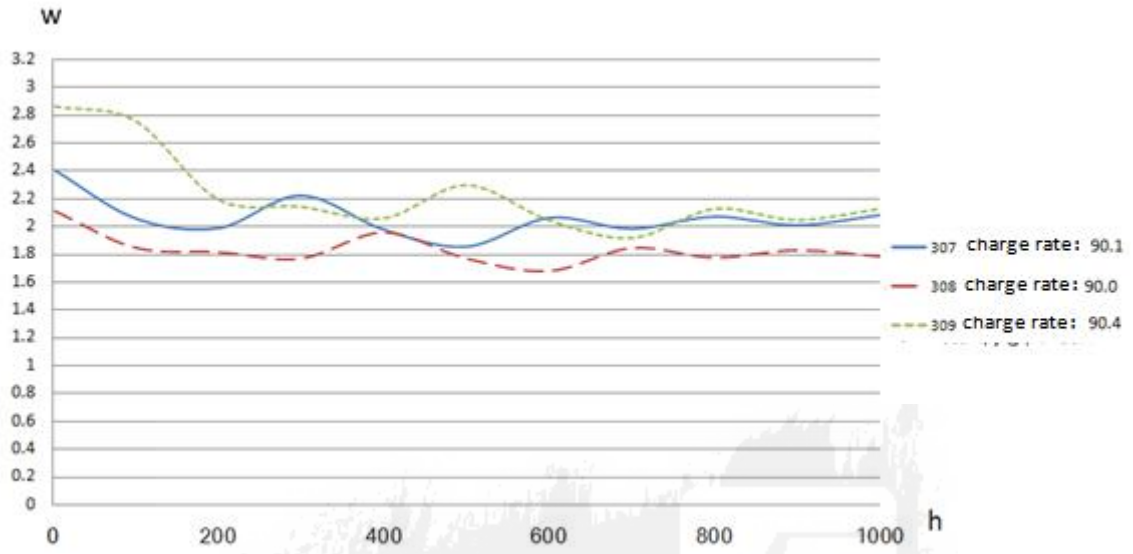
Fig 1 The Accelerated ageing curve of samples

Fulfilled the requirements, the accelerated ageing curves were shown in fig 1.

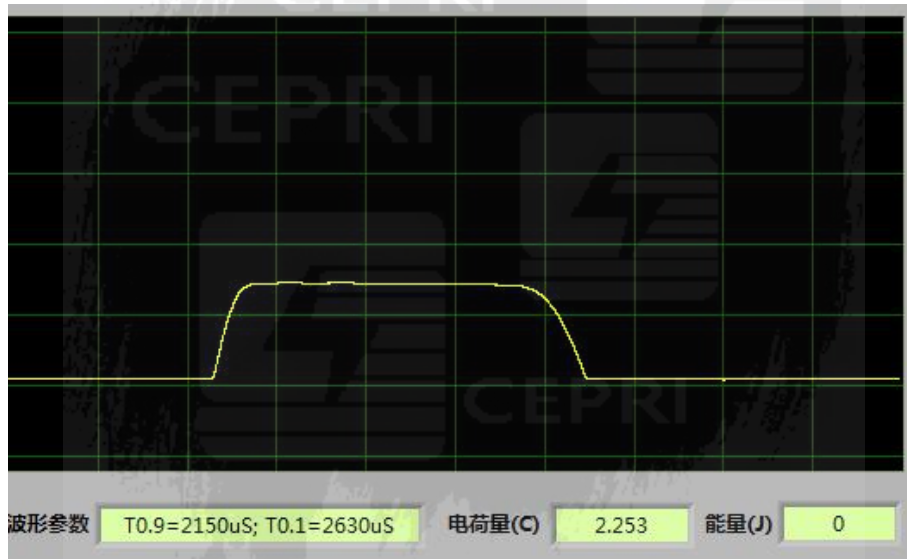
Fig C.5 The 1st time of sample 310, Repetitive charge transfer withstand, 0.01V/A

Fulfilled the requirements, the test waveforms were shown in fig C.5.

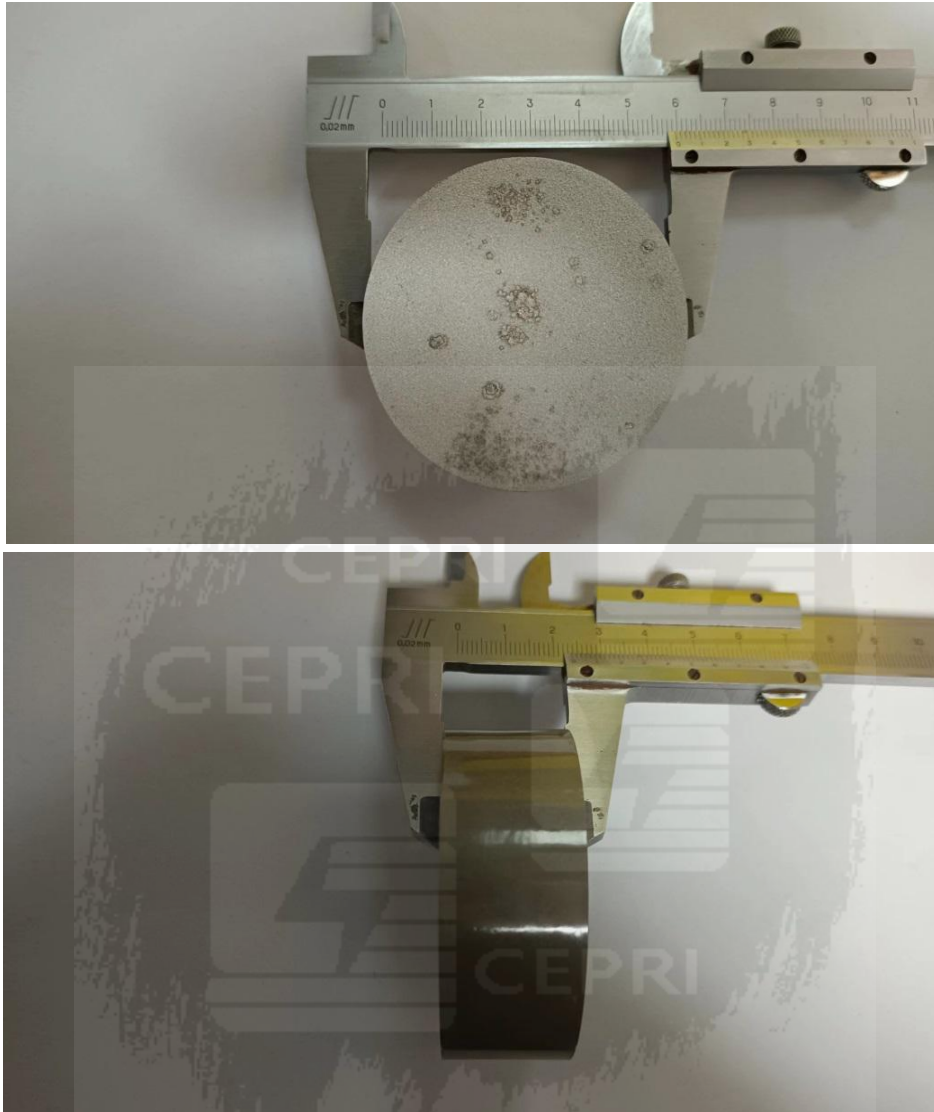
Fig D1: Outside view of MO resistor ($\Phi 60\text{mm} \times 24\text{mm}$)
